Manhole Inspection Summary

Manhole # S25I__043MH

Insp Date: **3/17/08 9:54 AM**

Location Address: **W.PRATT ST.**

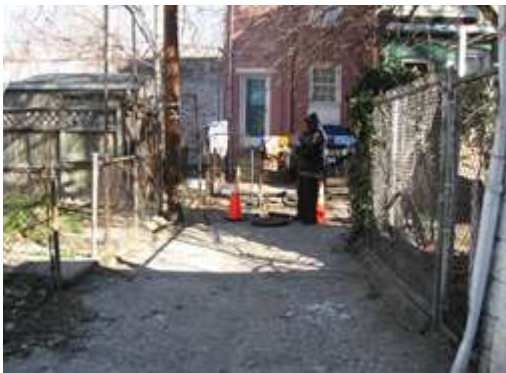
Location View

Comments **In alley behind 111 S Calhoun St. and north of W Pratt St.**

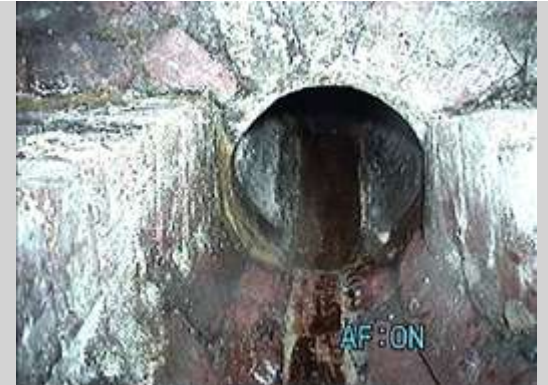
12 O'Clock Outflow

8 in. Circular Gravity Sewer
Pipe Out @ 12 O'Clock

Pipe Height: **8.4** (in.) Rod and Bar (Angled)
Pipe Material: **Clay** ☐ Pipe Lined
Invert Depth: **9.55** (ft.) Flow Characteristics: **None**
Deposits: ☒ None ☐ **Mud** ☐ Sludge ☐ Debris ☐ Grease
Silt Depth: **0** (in.) Deposits Extent:
Infiltration: **None** Pipe Seal Cond: **Sound**

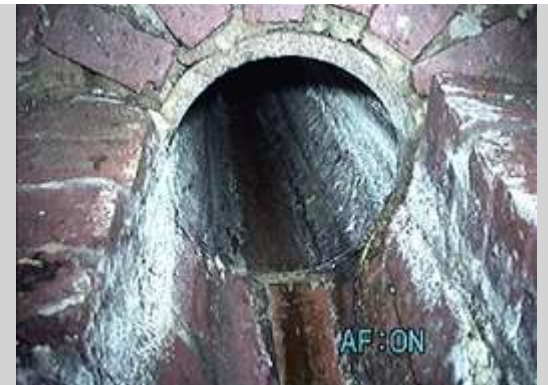
3 O'Clock Inflow

8 in. Circular Gravity Sewer
Pipe In @ 3 O'Clock

Pipe Height: **8.4** (in.) Rod and Bar (Angled)
Pipe Material: **Clay** ☐ Pipe Lined
Invert Depth: **9.00** (ft.) Flow Characteristics: **Slow**
Deposits: ☒ None ☐ **Mud** ☐ Sludge ☐ Debris ☐ Grease
Silt Depth: **0** (in.) Deposits Extent:
Infiltration: **None** Pipe Seal Cond: **Sound**
